## ECONOMIC DEVELOPMENT & TOWN ACTION PLAN COMMITTEE

- E 20/46 TOWN GREEN**  
To review proposals for the development of Town Green. To consider the following:  
[📎] 1. Topographical Survey [attached in part]  
[📎] 2. Arboricultural Survey [attached]  
[📎] 3. Advice and Proposal by EHDC Conservation Officer [attached]

## **Tree Survey**

Town Green

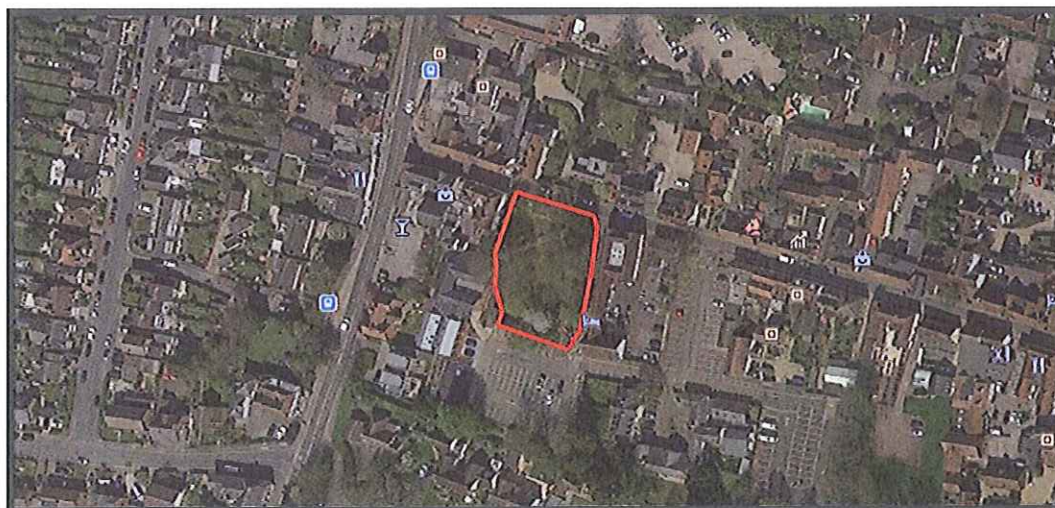
**Figure 1: Aerial Image of Approximate Site Boundary (Google Earth)**

Area of public access amenity space between car park and high street with seating and tree cover.

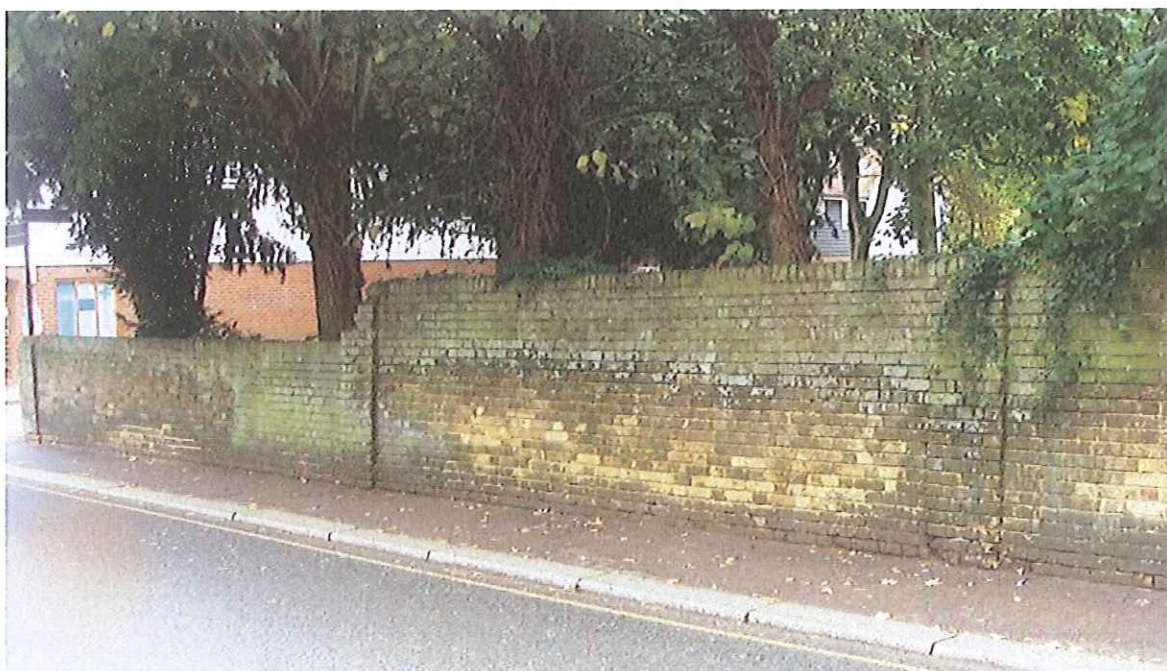
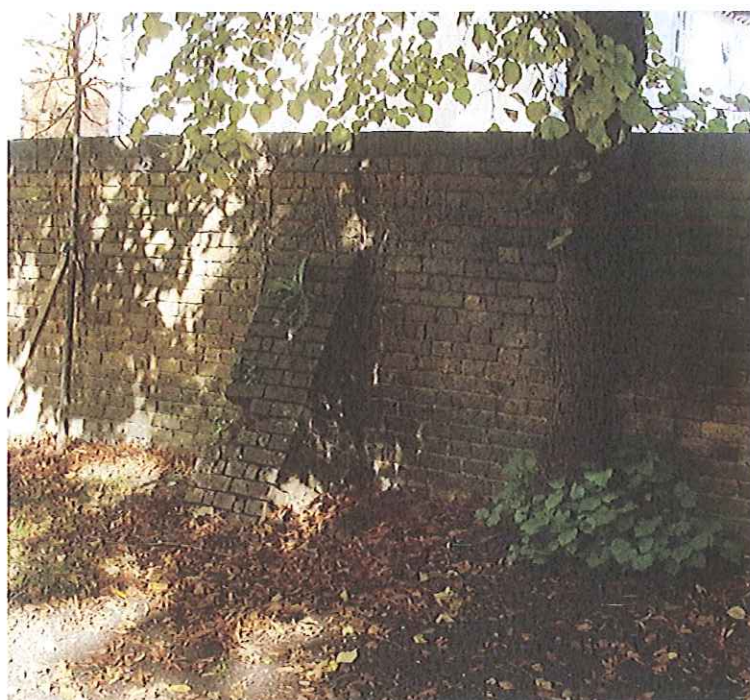
Picture 1-2. The Wall fronting Bell Street. Recorded in the Listed Building description as forming part of the adjacent listed building. Height varies 1.35-1.8 m. Probably earlier 20<sup>th</sup> century date. The wall provides an important sense of enclosure and complete demolition would be inappropriate. Alterations to reduce height by a modest amount and to provide a new entrance would need Listed Building consent and Planning Permission. Picture 2 shows buttress support placed later – stability of wall needs checking.

3. Reduce the height of the wall fronting Bell Street by a modest amount to agreed common height and provide a new centrally located entrance. This makes the enhanced open space visually more prominent and better used and enjoyed by the community. This to be subject to obtaining the necessary consents and resolving any access/highway safety issues. The wall forms part of the space and works involving alterations to it and provision of a new entrance should be considered as being part of an holistic scheme involving significant improvements to the open space itself. Simply providing a new access without

making real improvements to the space itself would be a lost opportunity. The wall appears to have moved out of the vertical in some parts and is supported by a buttress in one location. Its stability therefore needs consideration.

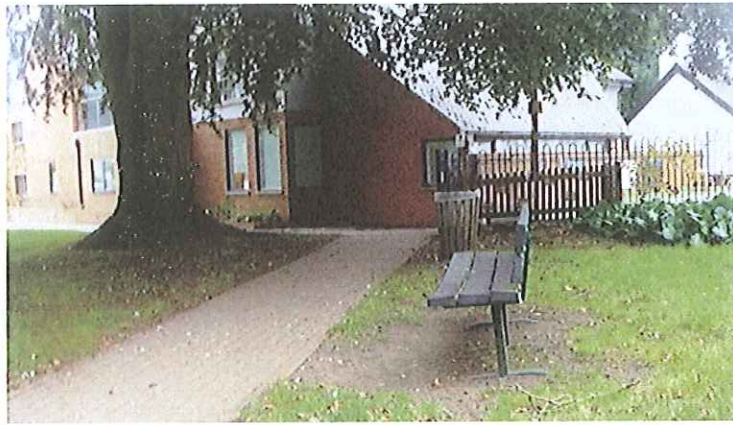
Picture 3. Diagonal path crosses and bisects the open space leading to Surgery. Various elements of street furniture of poor design. Worn and 'tired' grass areas. Fine beech tree which the Council's Arboriculture Officer advises is a variety which originates from the Rivers Nursery.

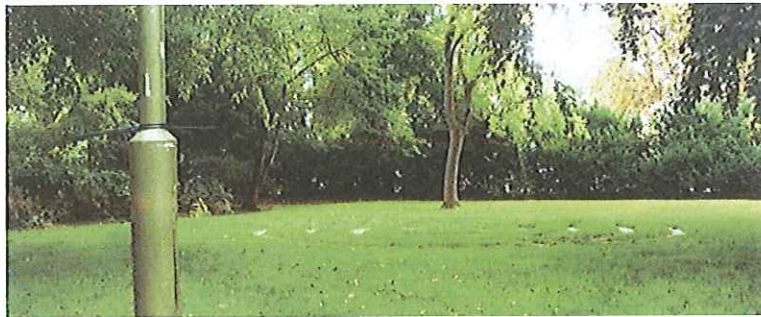
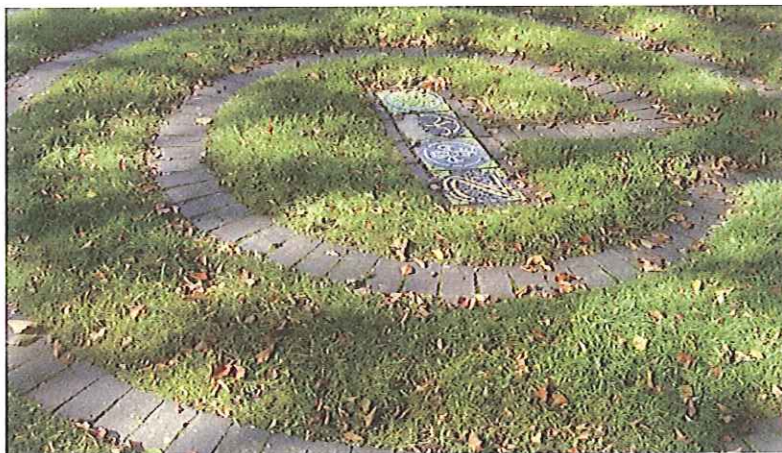
Picture 4 -5 There is a 'maze' within the area prepared and constructed by the local Scouts Group for the Millennium It is not prominent and as can be seen the central insignia feature damaged by mowing the author was informed. If as likely and as advised, local considerations dictate the maze remains; it could be improved and significantly enhanced. For example the circles of grass could be replaced with a

contrasting hard surface, a central feature to give vertical emphasis could be provide together with seating and perhaps low box hedge or other planting surrounding it.

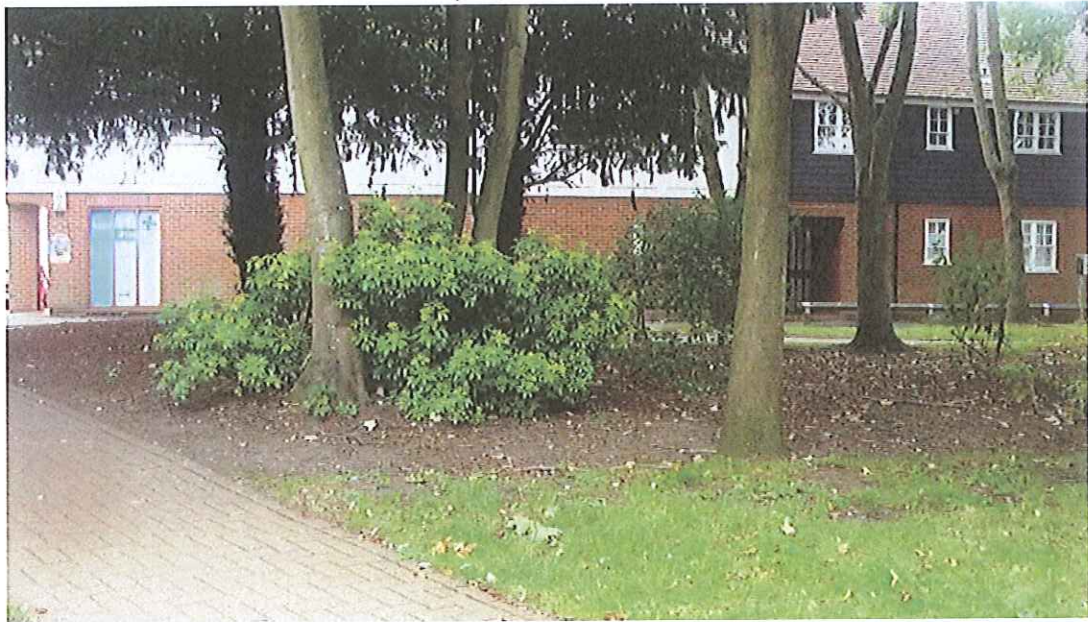
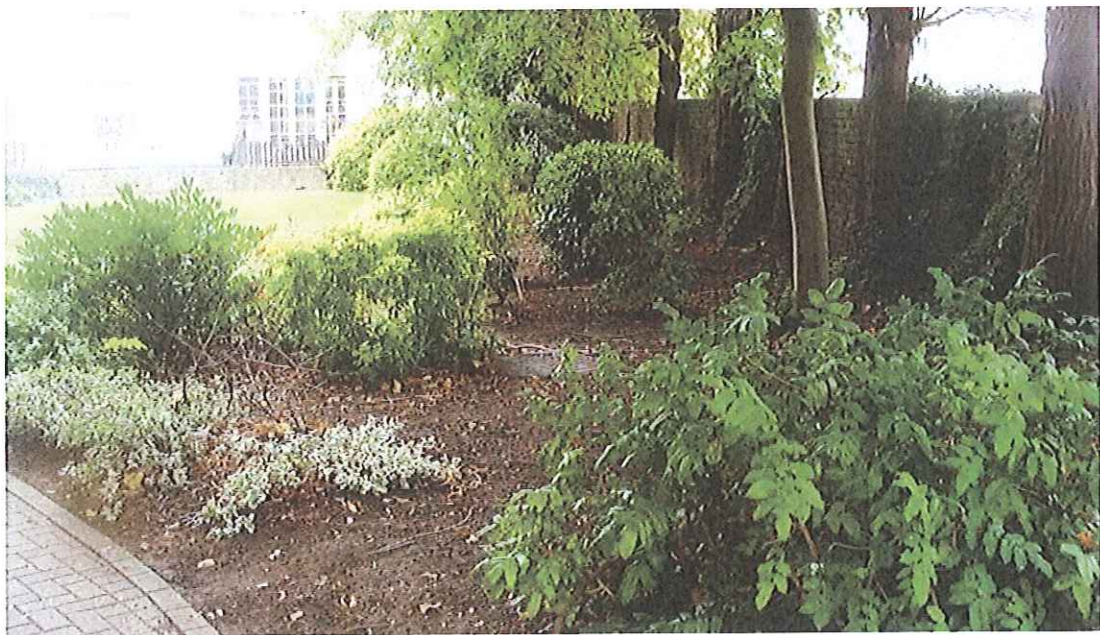
Pictures 6-7. Areas of tree and shrub planting which in the author's opinion is of limited landscape value. Bare earth particularly detracts. The deciduous trees are likely to be of a more recent date with no historic association with the original garden.

4. Subject to agreement from the Council's Arboriculture Officer remove trees and shrub areas so as to increase useable space and create a lighter atmosphere. Replacement planting: Both the Council's Arboriculture Officer and the author consider the incorporation of some Thomas Rivers (Victorian nursery had close historic association the town) replacement tree species could be an option and fruit varieties, if chosen, could be of additional community benefit. Consider involving the community in such planting. Possible high quality interpretation board. The Council's Arboriculture Officer will advise in relation to tree works and associated procedures.

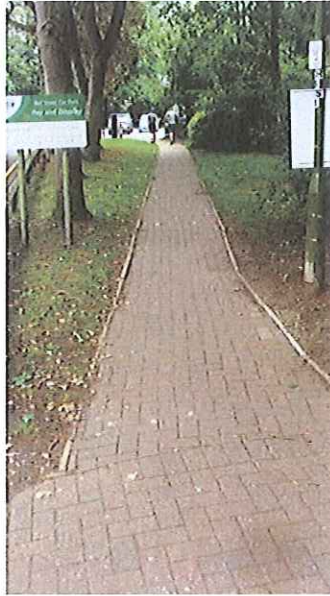
Picture 8. Pathway on eastern boundary leading to car park. Bare earth areas, street furniture and signage. An area of potential improvements, removal of some trees and possible replanting (Rivers varieties?) with views through to open space.
