**Groundwork East**  
Mill Green, Hatfield  
Hertfordshire, AL9 5PE  
TEL: 01707 260129  
herfordshire@groundwork.org.uk

PROJECT TITLE Jubilee Garden: Sawbridgeworth		CLIENT Sawbridgeworth Town Council	
DRAWING NAME Tree removal/ retention plan		DATE August '23	
DRAWING NUMBER 30128_002_003		SCALE 1:200 @ A3	
PROJECT ADDRESS Bell St, Sawbridgeworth CM21 9AQ	DRAWN BY GJD	CHECKED MM	REVISION B

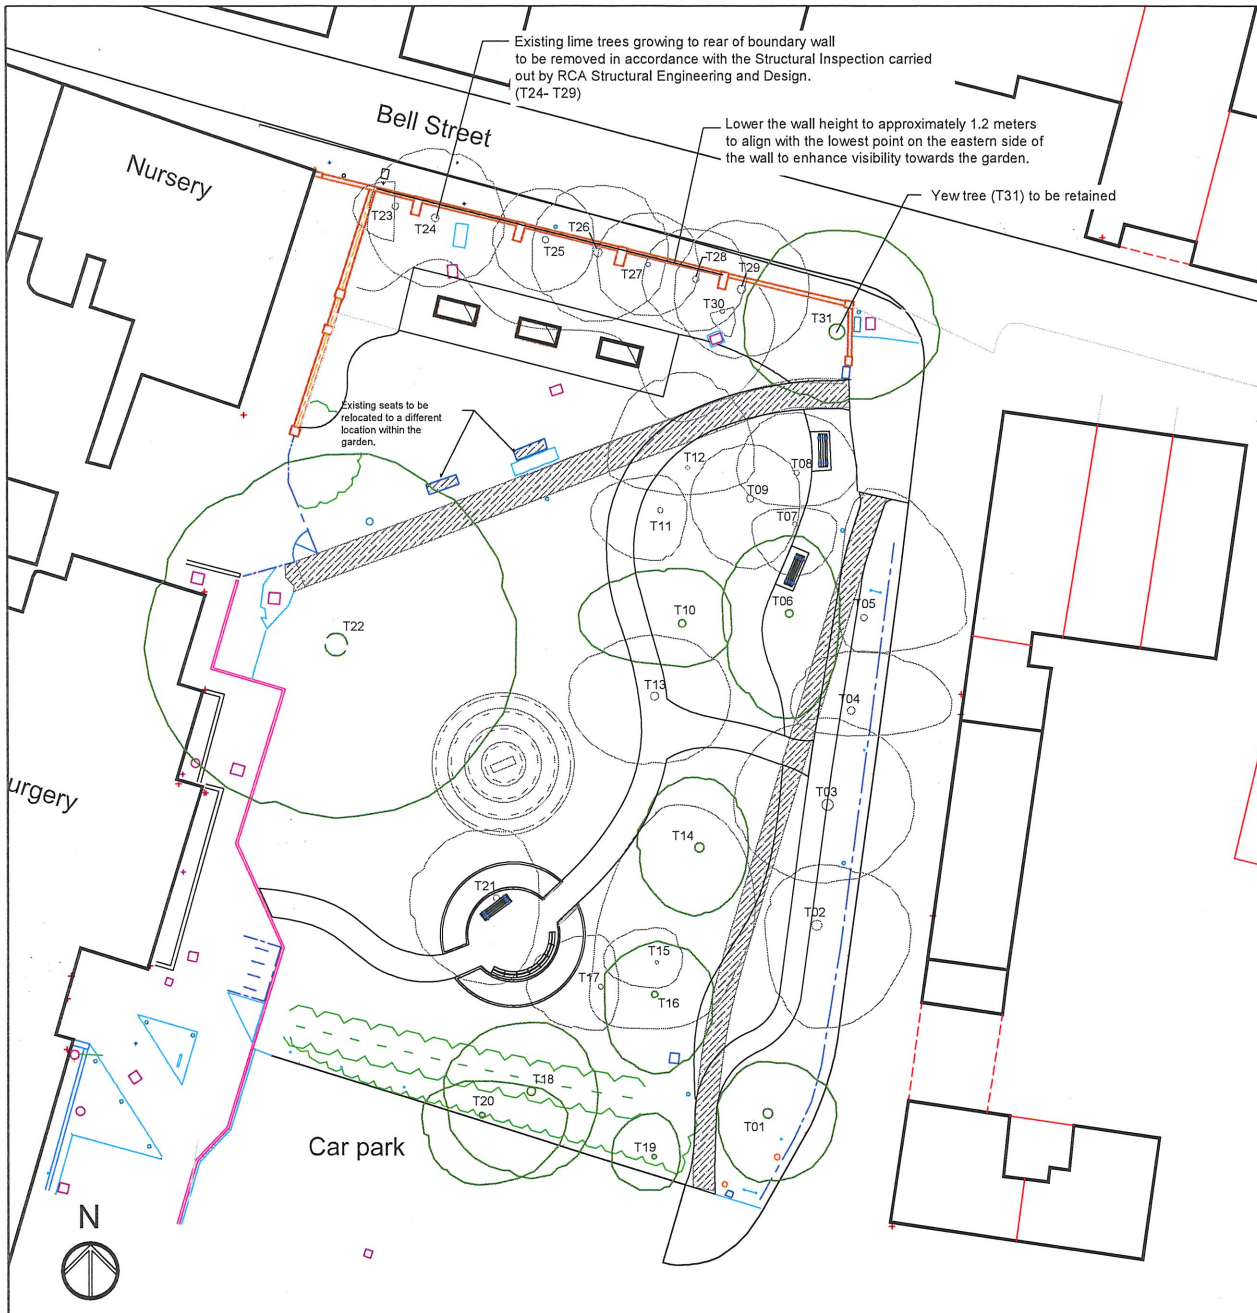
Existing site trees to be removed
-

Existing trees to be retained and protected
-

Existing block footpath to be removed
-

Existing bench to be relocated to a different location within the garden

- T02- Horse chestnut Category B- Tree of moderate quality
- T03- Sycamore (*Acer pseudoplatanus*) Category B- Tree of moderate quality
- T04- Common ash (*Fraxinus excelsior*) Category B- Tree of moderate quality

- T05- Common ash (*Fraxinus excelsior*) Category B- Tree of moderate quality
- T07- Common Yew (*Taxus baccata*) Category C- Tree of low quality
- T08- Common Yew (*Taxus baccata*) Category C- Tree of low quality

- T09- Sycamore (*Acer pseudoplatanus*) Category B- Tree of moderate quality
- T11- Norway maple (*Acer platanoides*) Category C- Tree of low quality
- T12- Sycamore (*Acer pseudoplatanus*) Category B- Tree of moderate quality

- T13- Small leaf lime (*Tilia cordata*) Category B- Tree of moderate quality
- T15- Common yew (*Taxus baccata*) Category C- Tree of low quality
- T17- Cherry (*Prunus Spp*) Category C- Tree of low quality

- T21- Hurlingdon Elm Category C- Tree of low quality
- T23- Sycamore (*Acer pseudoplatanus*) Category C- Tree of low quality
- T24- Common Lime (*Tilia cordata*) Category B- Tree of moderate quality

- T25- Common Lime (*Tilia Cordata*) Category B- Tree of moderate quality
- T26- Common Lime (*Tilia Cordata*) Category B- Tree of moderate quality
- T27- Common Lime (*Tilia cordata*) Category C- Tree of low quality

- T28- Common Lime (*Tilia cordata*) Category B- Tree of moderate quality
- T29- Common Lime (*Tilia cordata*) Category B- Tree of moderate quality
- T30- Common Ash (*Fraxinus excelsior*) Category U- Standing dead tree

- T01- Norway maple (*Acer platanoides*) Category B- Tree of moderate quality
- T06- Common ash (*Fraxinus excelsior*) Category B- Tree of moderate quality
- T10- Sycamore (*Acer pseudoplatanus*) Category B- Tree of moderate quality
- T14- Sycamore (*Acer pseudoplatanus*) Category B- Tree of moderate quality
- T16- Cherry (*Prunus Spp*) Category B- Tree of moderate quality
- T18- Sycamore (*Acer pseudoplatanus*) Category B- Tree of moderate quality
- T19- Plum (*Prunus Domestica*) Category C- Tree of low quality
- T20- Plum (*Prunus Domestica*) Category C- Tree of low quality
- T22- Copper Beech (*Fagus sylvatica Purpurea*) Category A- Tree of high quality
- T31- Common yew (*Taxus baccata*) Category B- Tree of moderate quality
